MEASUREMENT CERTIFICATE

Number of Measurement Certificate: 3-065-14

**Estonian Defence Forces central proving ground
November 2nd, 2014**

**Measurement of acoustic parameters in defence structures and
assessment of health impact**

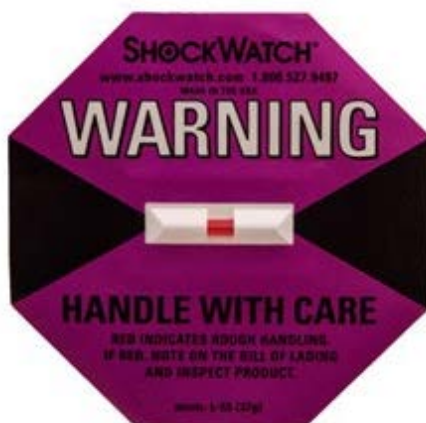
Figure 2: ShockWatch Label with a burst ampoule

The stickers contain calibrated ampoules that shall break under a shock or blow with a predetermined strength and duration, painting the ampoule red (see Figure 2). To qualitatively evaluate the strength of shocks and blows felt by the users of the bunker, several stickers with a different sensitivity setting were used:

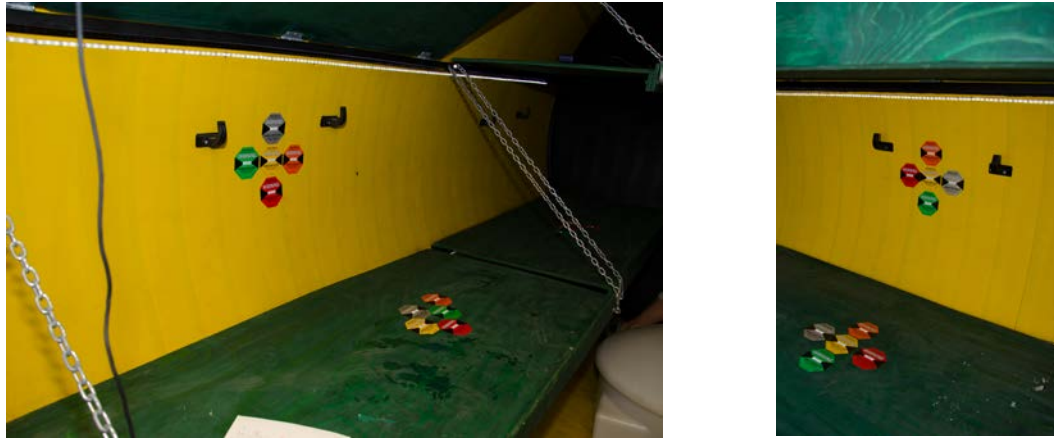
Stickers were placed on the walls of the bunker and the bunks of the middle stack, presuming that the amplitude of any pressure wave is the highest at the middle of any cylindrical body. The layout of the stickers has been provided on Figure 3. In case any of the stickers are activated during the

Figure 3: The layout of the ShockWatch stickers on the walls and bunks of the bunker.

After the end of the exercise, the condition of the stickers was inspected, and it was determined that none of them were broken. Thus, it can be concluded that the shocks and blows inside the bunker remained within limits that are safe for the health during the whole of the testing period.
